2000 Antwerp, terraced house

IEA – SHC Task 47

Renovation Residential Buildings towards Sustainable Standards

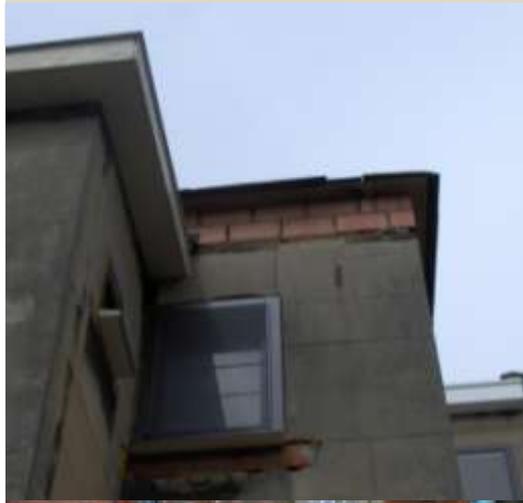
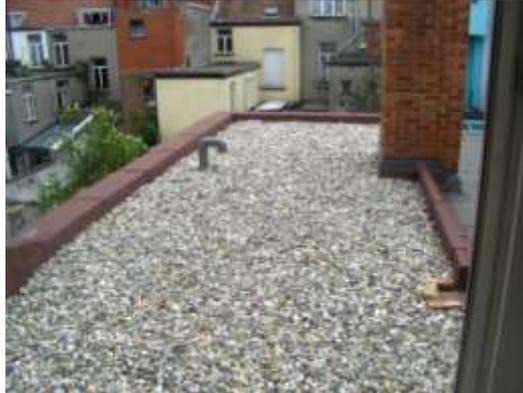
Step 1: thermal insulation of the roof and adaptation of the roof to accommodate façade thermal insulation

*1999: Central area and flat roof were insulated.
Preparation for the future connection with the insulation of the back façade.*

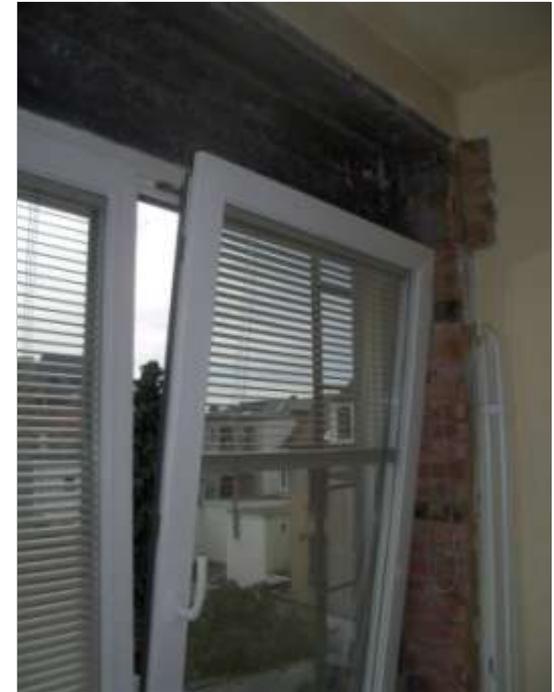
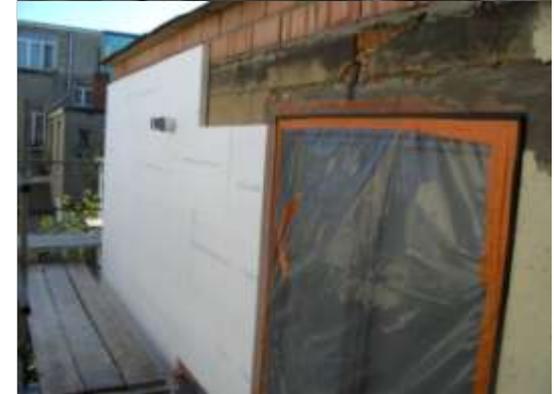
Step 2: new windows and façade insulation

2007-2008: Insulation of the side and back façade, Change of the single glazing windows to windows with double or triple glazing,

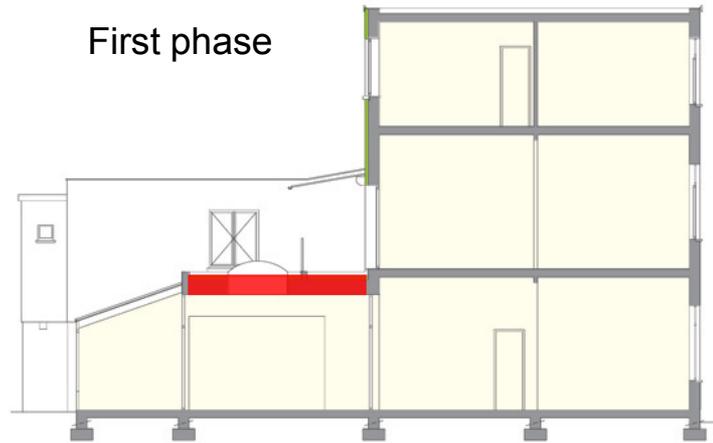
First phase

- Insulation of flat roof in extension
- Preparation of the future connection between roof and exterior insulation

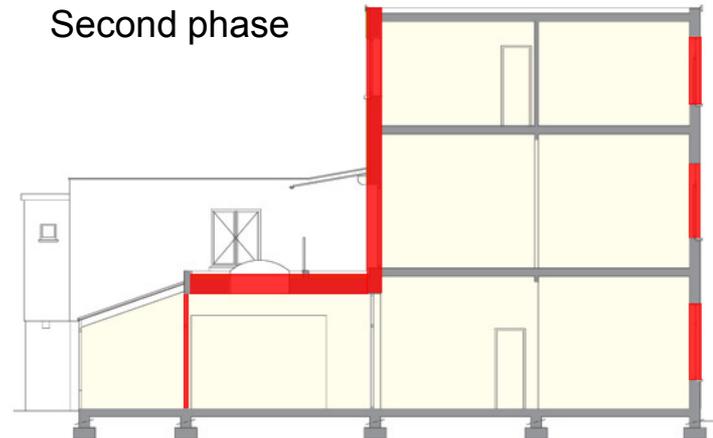
Second phase

- Exterior insulation of the back facade
- Replacement of windows from single glazing to double or triple glazing
- Wall treatment against humidity

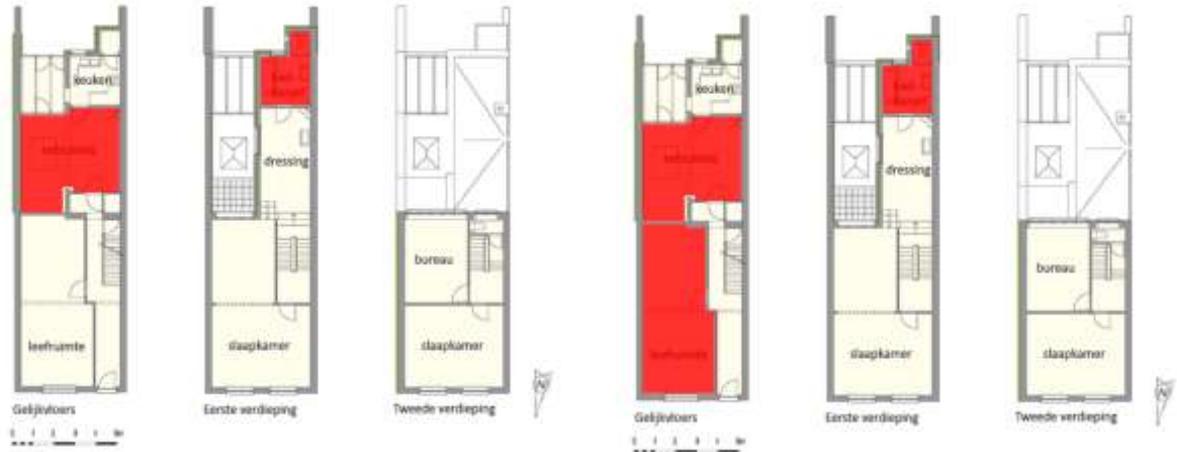
Heated rooms

Winter strategies during the day

Winter strategies during the night

The owners have found a system to heat up the building per area. Bathroom and dinning room are heated during the day and during the night they also heat up the living room.

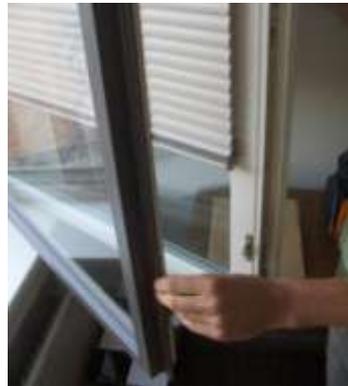
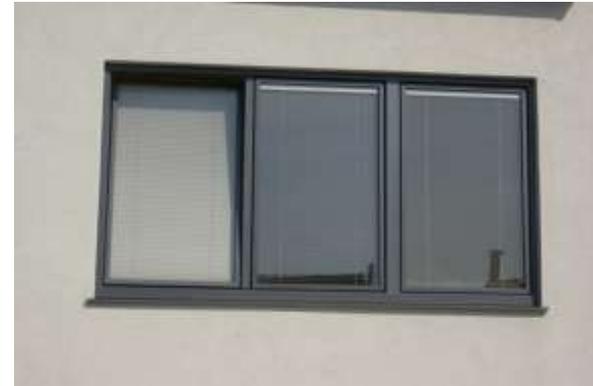
Solar protection

On the facades where solar protection was necessary, an innovative system where the protection is integrated in the windows, was placed.

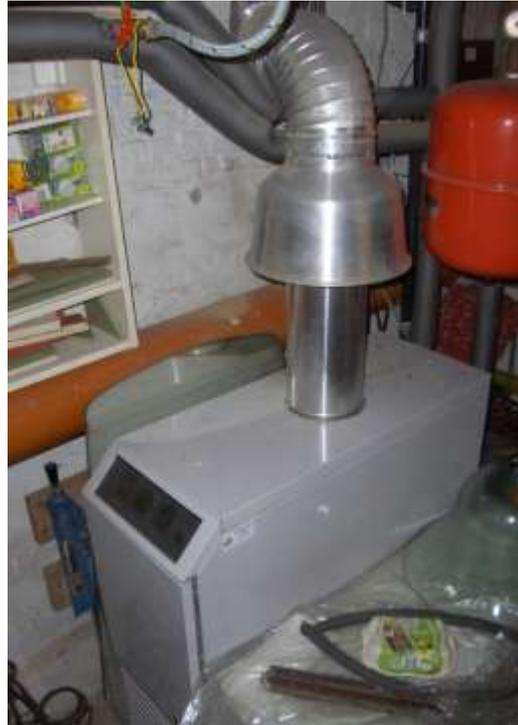
Existing high-performance boiler

A high performance boiler was installed in 1995 is still in use.

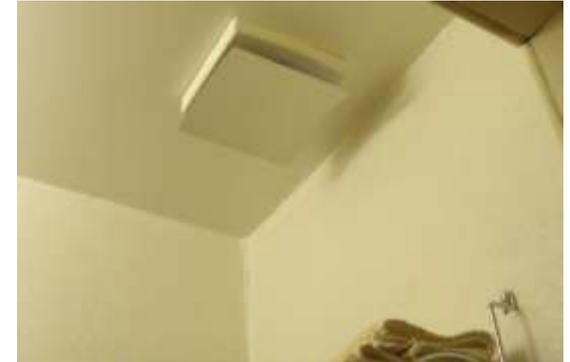
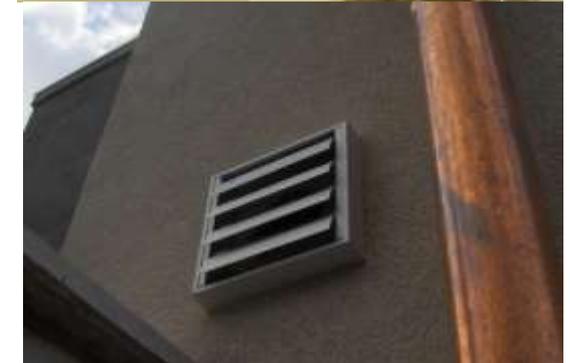
Exhaust fan with humidity dedection in the bathroom and exhaust ventilation grille in the rear façade.

No ventilation system. To avoid the condensation problems in the bathroom, A ventilator with humidity detector was installed. Kitchen and bathroom are one above of the other to have shorter pipes.

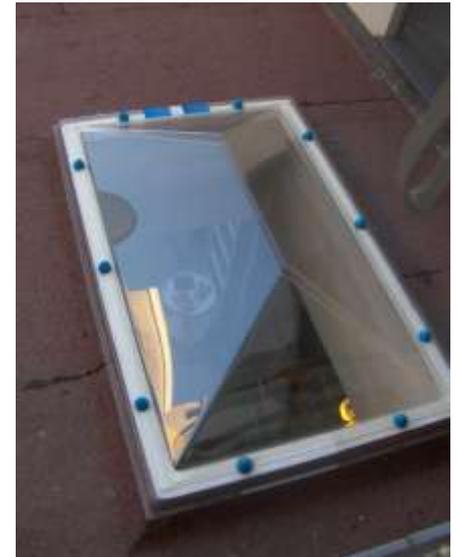
The building has large glazing areas. To have even more daylight entrance, a new sky light was added on the flat roof above the dining room.
