## **ERA-NET Eracobuild project**

**One Stop Shop - “From demonstration projects towards volume market: innovations for one stop shop in sustainable renovation”**

### **Project Report WP 3.1**

### **Additional case descriptions**

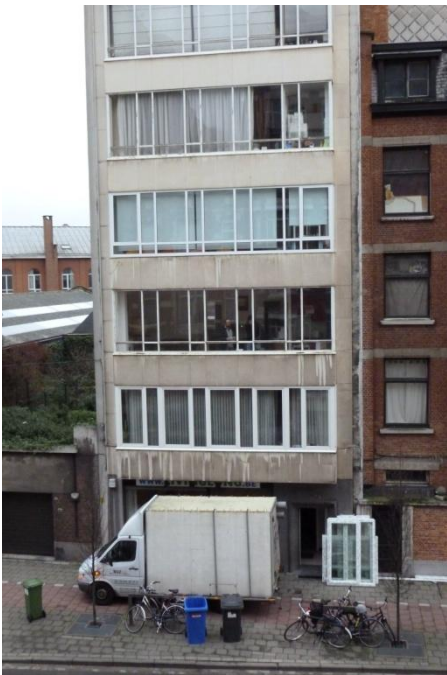
Figure 1 shows the original situation: the single-glazed steel windows on the second floor are already heavily deteriorated; other apartments in the same building already did some window renovation. Prolonged lack of maintenance already led to drip contamination on, and degradation of the façade.

Figure 1: Original situation.

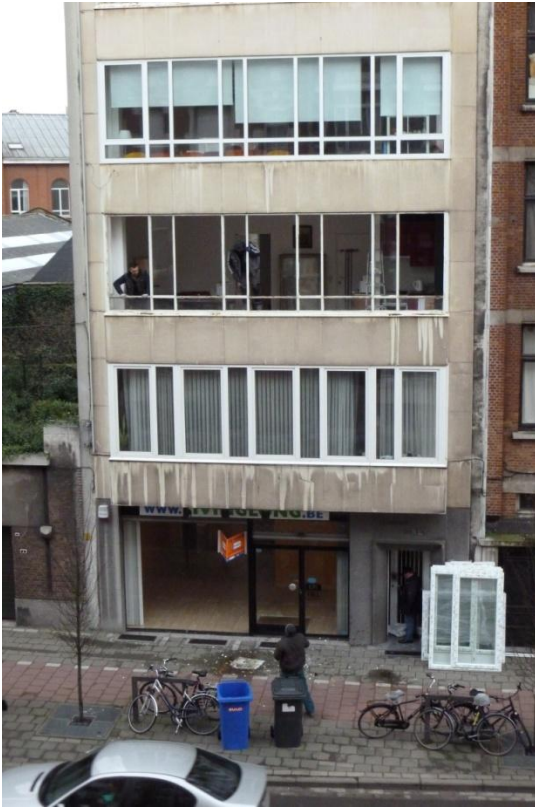
Figure 1/2 shows that the craftsmen were inventing on-site how to deal with the existing situation. The new windows were left outside because they were too large to enter the building. Neither parking nor a safety perimeter was arranged in advance. The original single glass panes were destroyed with a hammer. Obviously, the craftsmen could not avoid glass pieces falling on the street and on the new windows. A man stayed downstairs to 'watch' for falling pieces and to do some cleaning with a brush. Cutting machinery was used to cut the steel windows (see Figure 3). No special fire safety precautions were taken (the apartment was inhabited and stacked with furniture), neither was eye protection used.

Figure 2: Destruction of original windows by hammering.

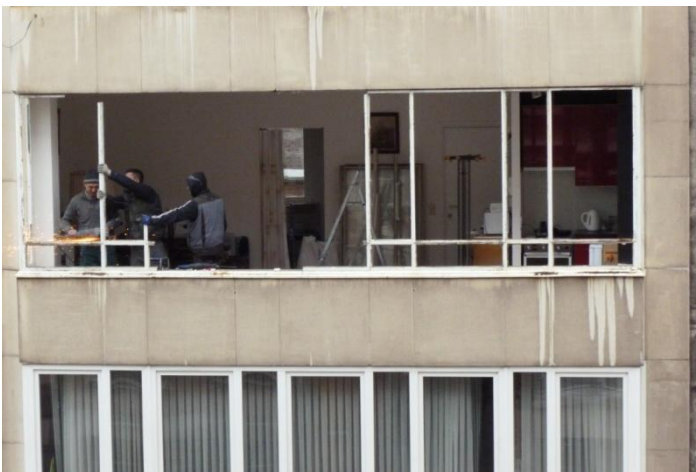
Figure 3: Destruction of original windows by cutting.

The destruction of the original windows led to degradation of the outside cement layer of the façade. Notably, the upper left- and right-hand corner, as well as the lower right-hand corner broke to pieces. During the whole renovation, no attempts were made to restore the façade. After the destruction of the original windows, the craftsmen did nothing for several hours. Obviously, there were waiting for an elevator machine that did not arrive on time. Figure 4 shows the assembly of the new windows after the elevator arrived. It was dark with freezing outdoor temperatures before the first window could be placed.

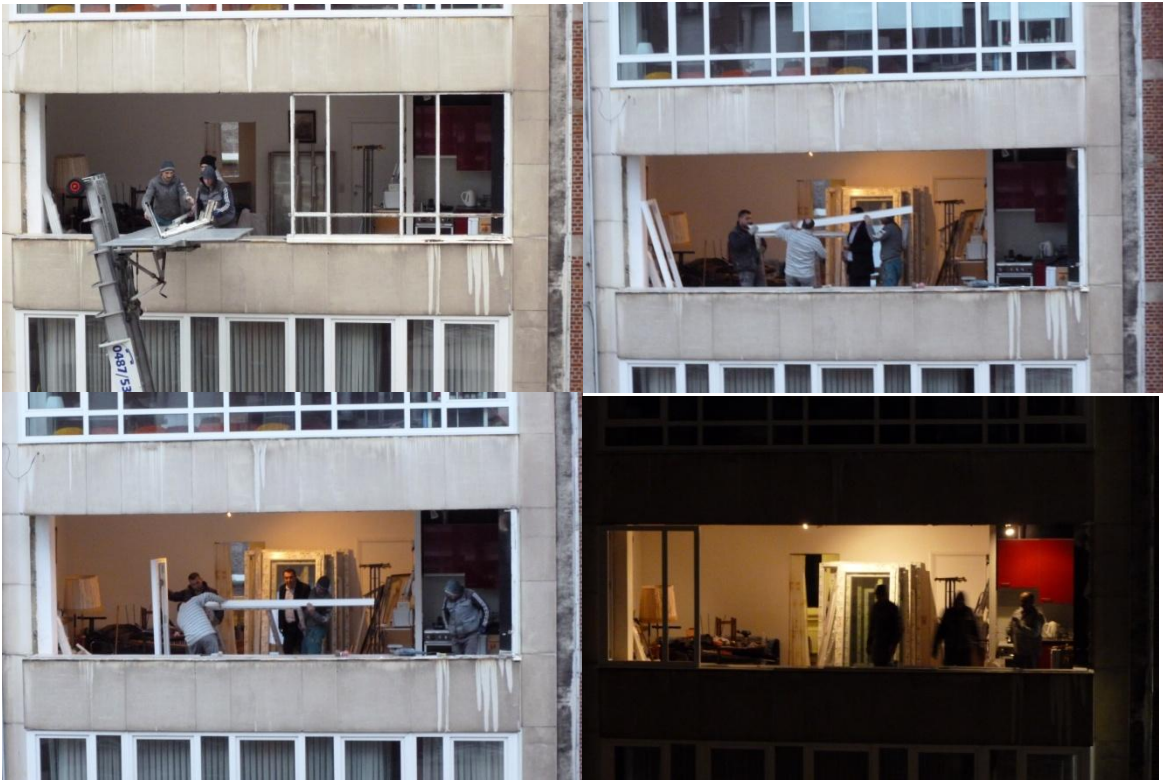
Figure 4: Window assembly on the first day.

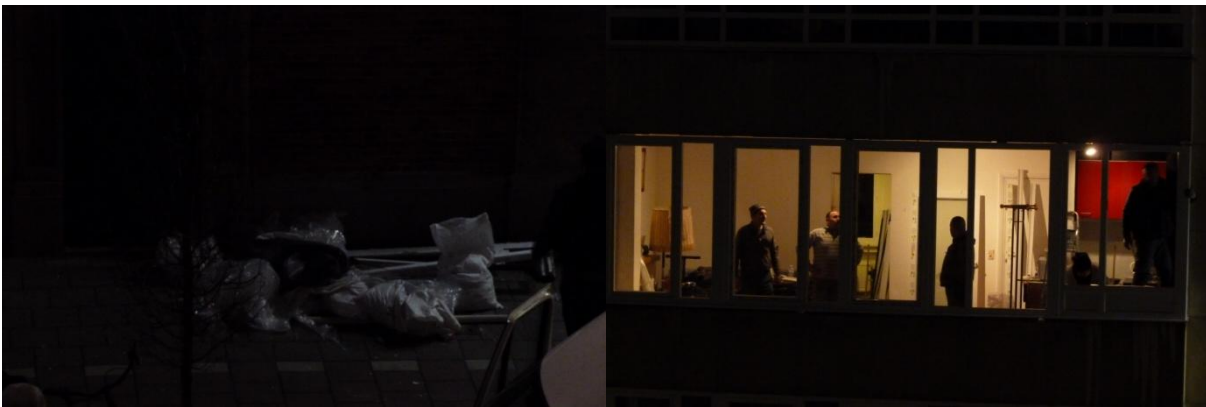
Figure 5 shows that at the end of Day 1 the installation of the (only) façade window system was not yet complete. Since this was the living room of the inhabitant, the apartment remained not fit for residence until the evening of the next day. Construction trash was left to linger on the street, later all trash was assembled in one container with no selective recycling.

Figure 5: End of Day 1: Trash on the street (left); windows placed (right).

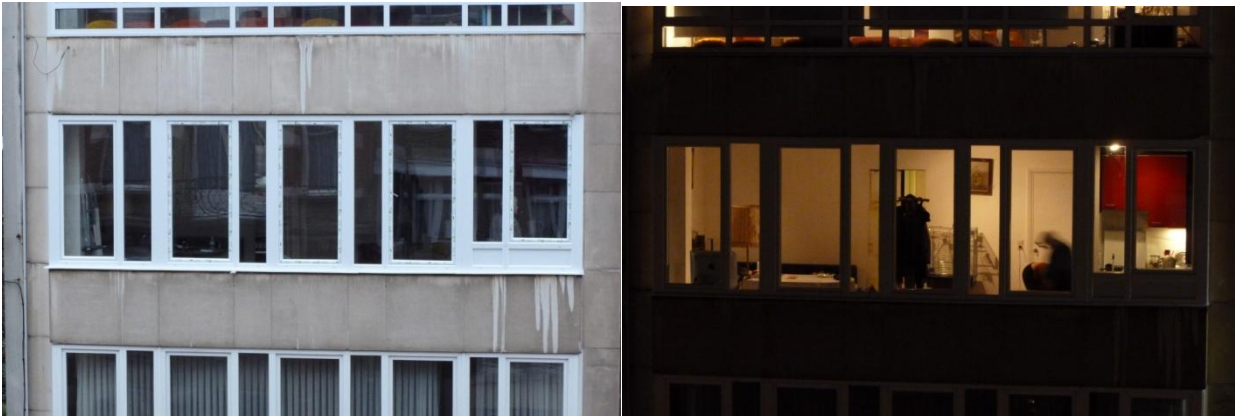
Figure 6: Day 2

The building process continued until the end of day two. On day two the craftsmen engaged in finishing plasterwork on the inside. No attempts were made to repair the façade on the outside, although the craftsmen were responsible for damages. At the end, the owner still had to do a major cleaning.

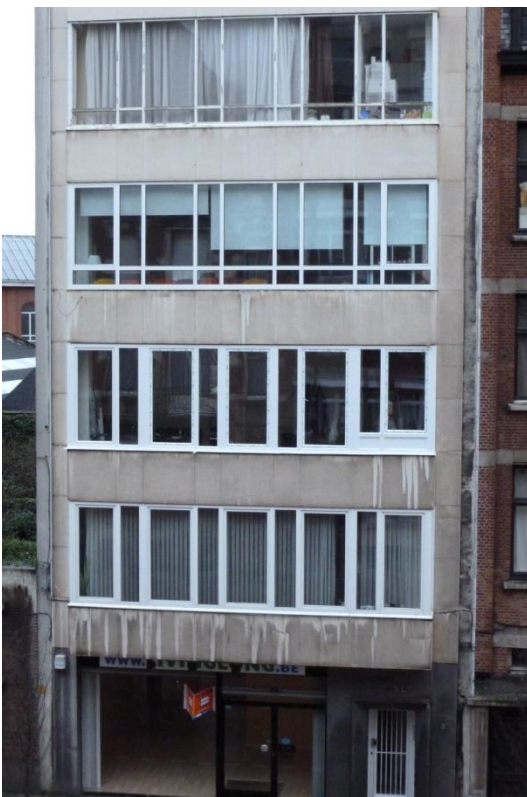
The final result is shown in Figure 7: the new window system has absolutely no uniformity with the windows on the other floors. The renovation is not expected to have led to an increase in value of the building. The owner is left with mediocre energy performance, lack of airtightness due to cement cracks and extra costs for reparation. The government will get the bill for this renovation, since more than 40% is recovered from tax reduction or grants for energy saving measures.

Figure 7: final result: eclectic renovation anno 2012 in Antwerpen.

Here only one renovation measure (replacement of windows) already led to detecting more than ten quality deficiencies. Such visible evidence does not really convince clients to invest more in (more) renovation (measures), in contrast it increases the perception that renovation is a high-risk activity. It appears that with implementing single measures such as window replacement, quality is not guaranteed. Yet, such window replacements take place regularly and are promoted by policy measures and web platforms<sup>1</sup>. It is important to look for less intrusive and less costly solutions.

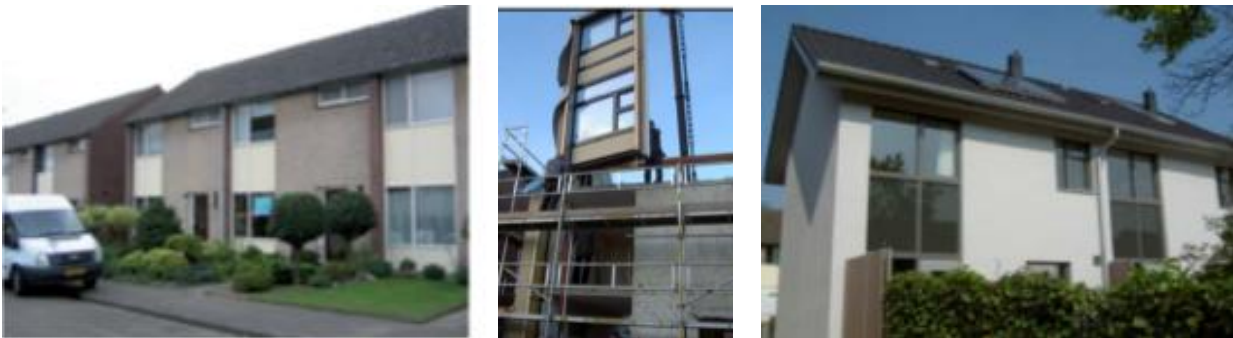
In two adjacent areas in the neighbourhood De Kroeven in Roosendaal, 246 houses have been renovated to Passive House standards. The project is now completed with the construction of new Passive House apartments and other house types which replace 30% of the original housing stock. The full process from initiative to completion can be considered a very important process innovation and many difficulties have had to be solved along the way, which led to the introduction of architectural innovations such as prefab façades and service innovations such as performance guarantee contracts for inhabitants. In this case, the whole façade, roof and installations were renewed in five days per house, while upgrading the whole neighbourhood. A prefab façade system was used that allowed for high quality and low construction time. The housing estate convinced more than 100 inhabitants to adopt the same type of renovation, using a demonstration project as a vehicle for volume uptake of innovation. While the example does not suggest direct solutions for the problems discovered in the previous case, the example shows what is technically and socially feasible regarding housing renovation nowadays when more than one building or apartment is dealt with.

Figure 8: Prefab renovation of a housing estate in Roosendaal, the Netherlands (visited with Flemish One Stop Shop user group 08-09-2011). Left: houses before renovation; mid: prefab façade system used during renovation; right: after renovation. Source: IEA SHC Task 37.
